# Guam Waterworks Authority (VP0989)

## CWA Collection System

Tumon, Guam

NEIC Field Investigation Photographs  
April 24 through May 4

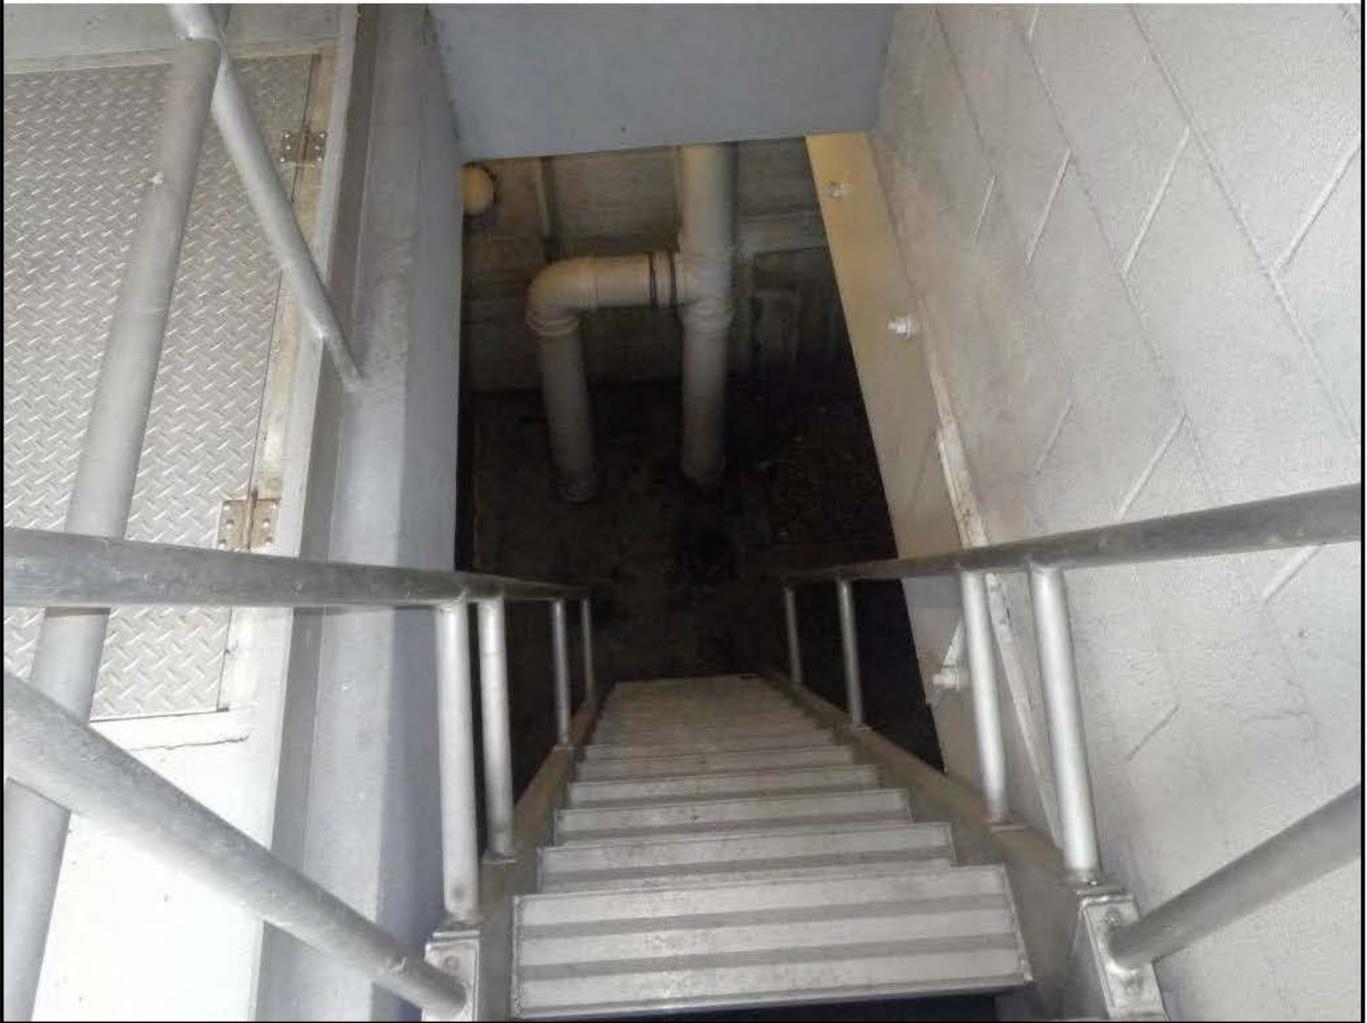
File Name: RIMG0114.JPG

<b>Title</b>	Guam Waterworks Authority (VP0989)
<b>Subject</b>	CWA Collection System
<b>Date Time Stamp</b>	5/1/2012 11:23:58 AM
<b>Photographer</b>	D. Vanlerberghe
<b>Description</b>	Agana Main pump station wet well.

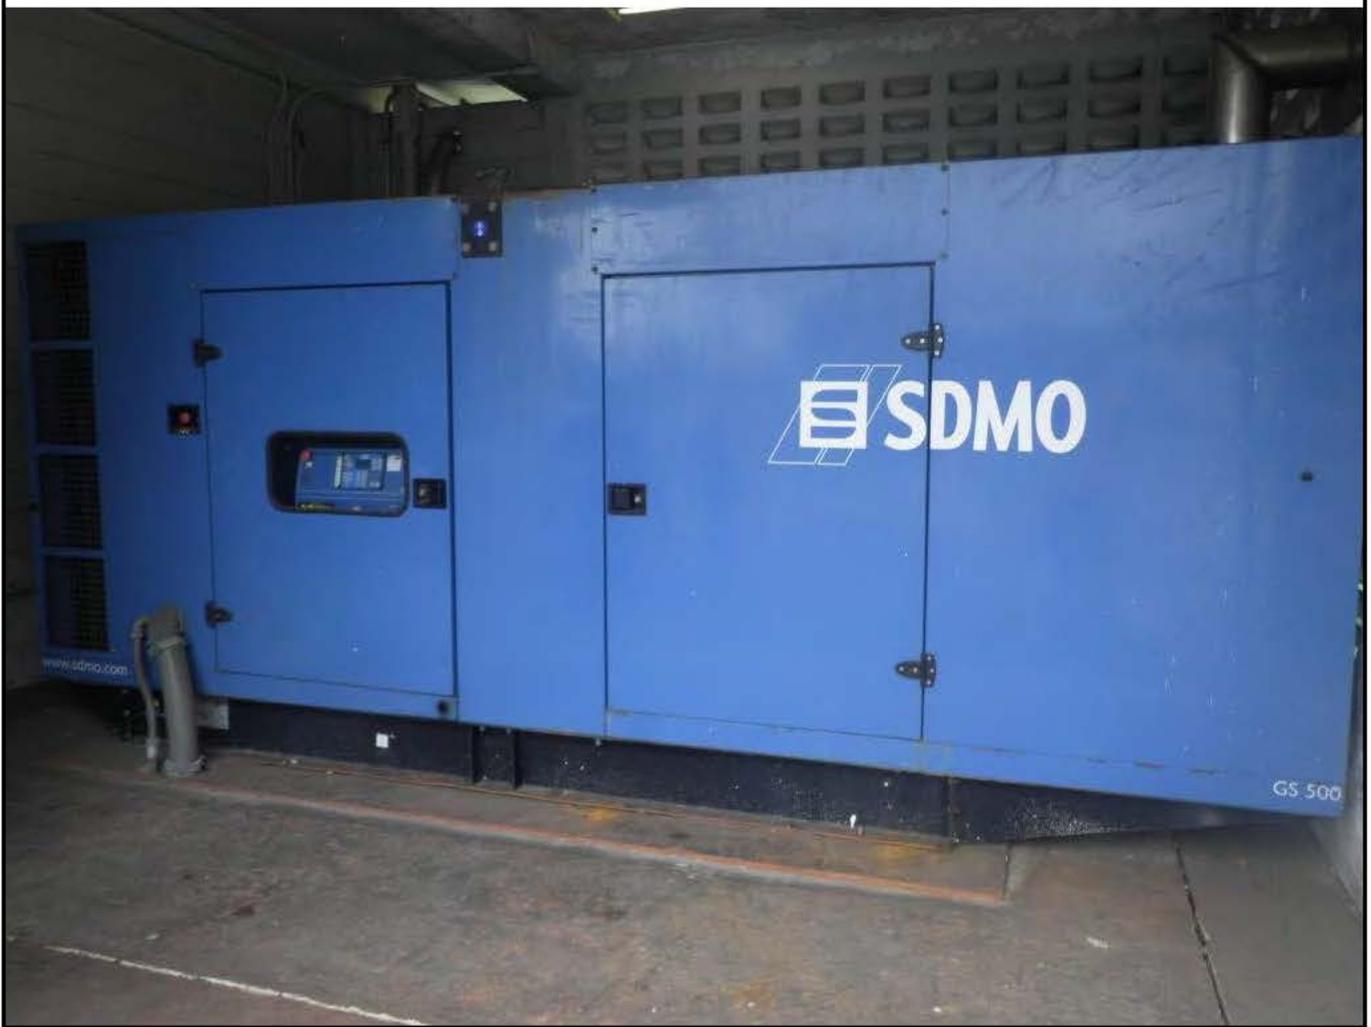
File Name: RIMG0115.JPG

Title	Guam Waterworks Authority (VP0989)
Subject	CWA Collection System
Date Time Stamp	5/1/2012 11:26:14 AM
Photographer	D. Vanlerberghe
Description	Agana Main pump station stanby generator (fuel tank underneath generator).

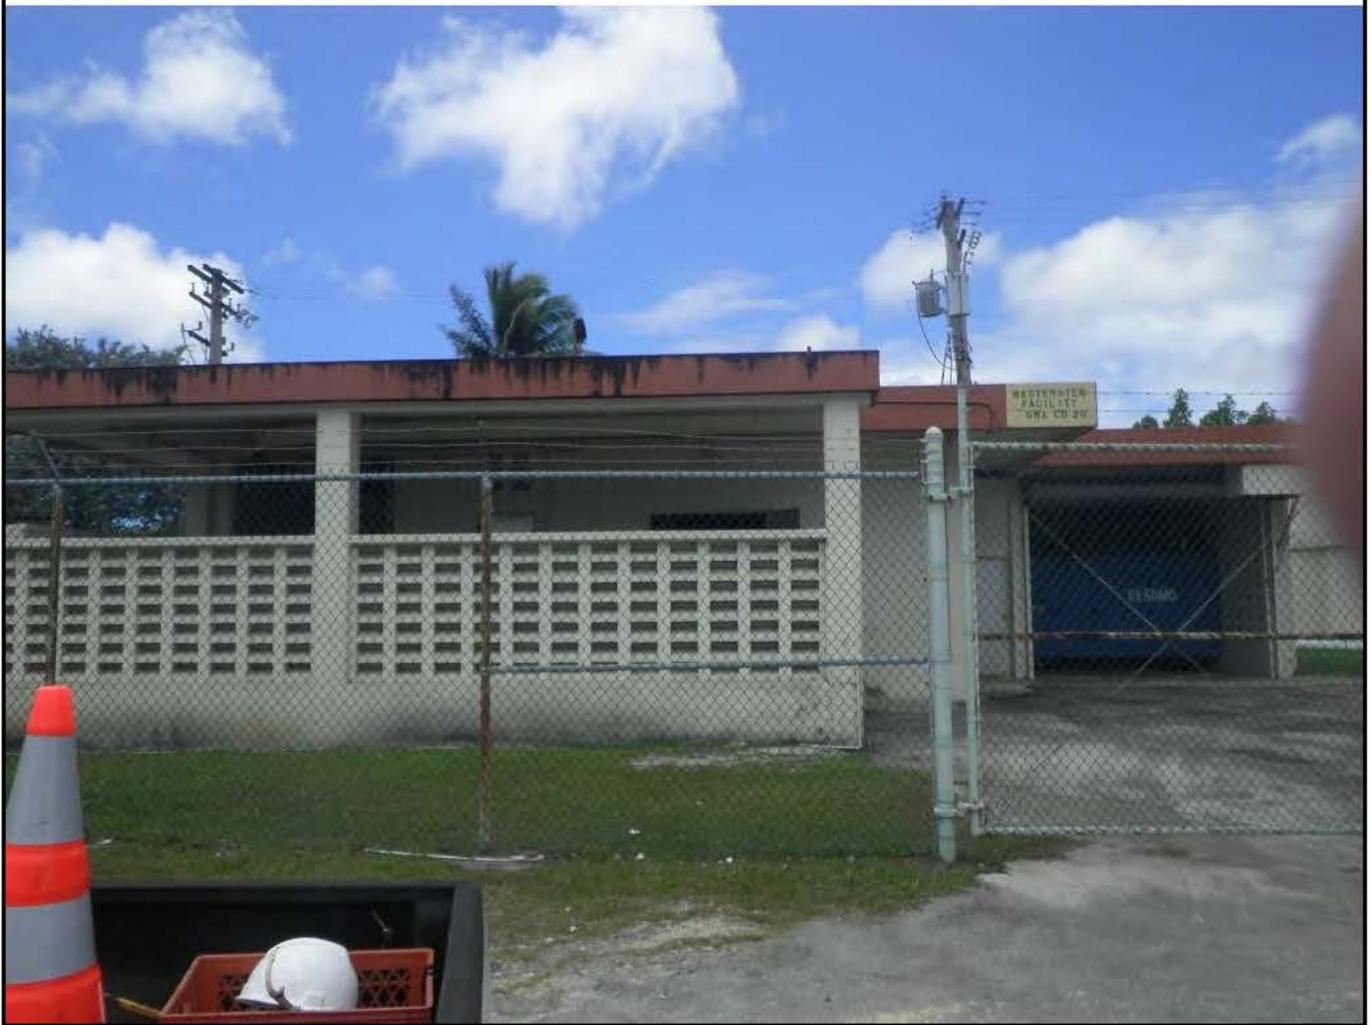
File Name: RIMG0116.JPG

Title	Guam Waterworks Authority (VP0989)
Subject	CWA Collection System
[REDACTED]	[REDACTED]
[REDACTED]	[REDACTED]
Date Time Stamp	5/1/2012 11:28:51 AM
Photographer	D. Vanlerberghe
Description	Agana Main pump station building.

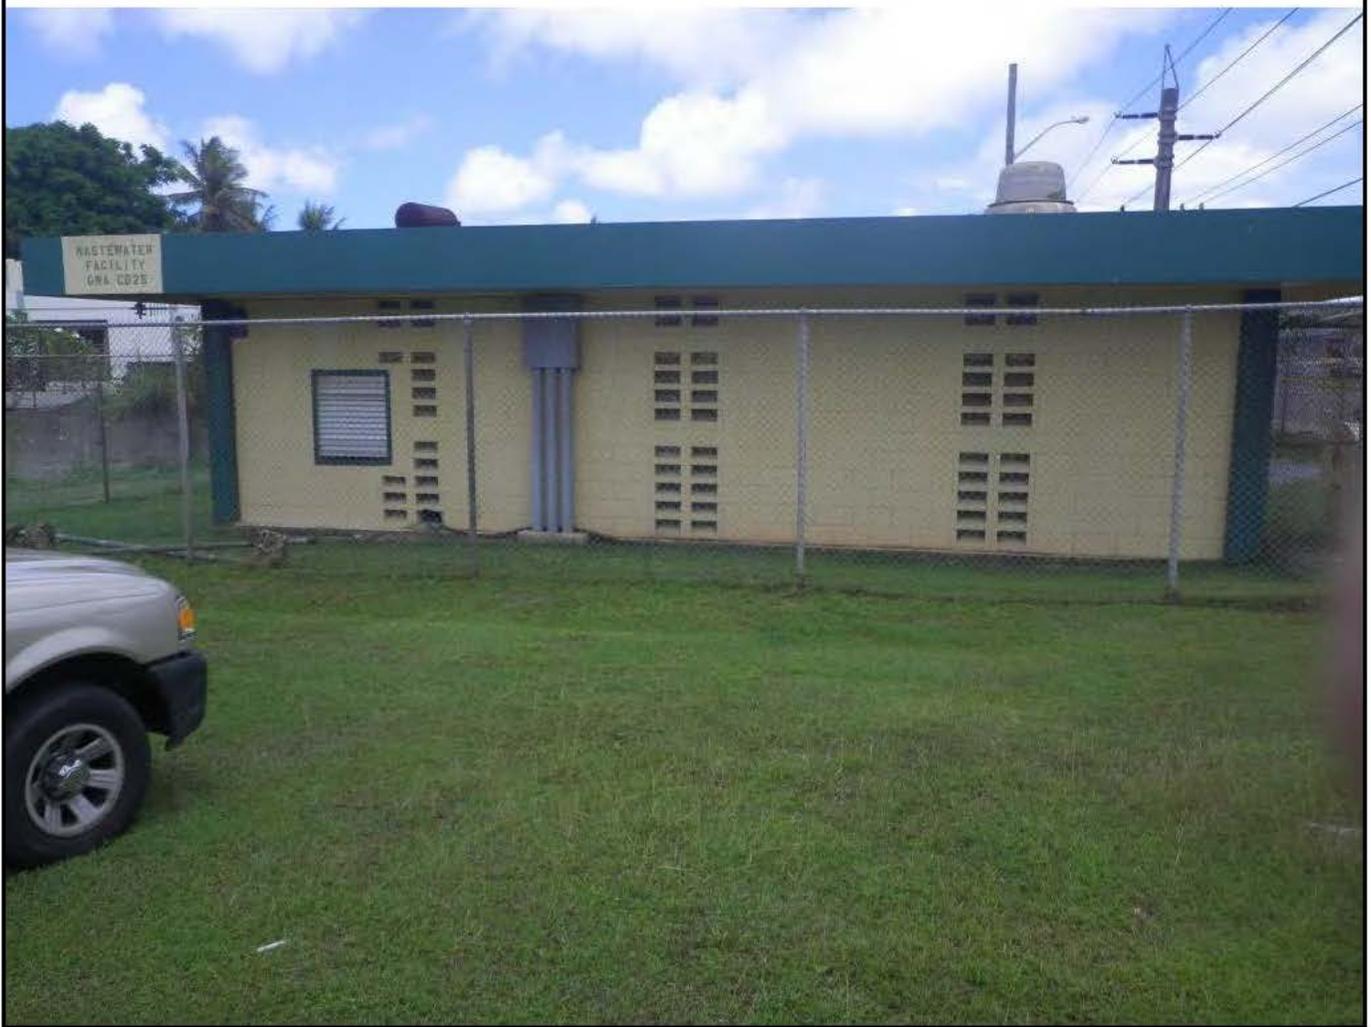
File Name: RIMG0117.JPG

Title	Guam Waterworks Authority (VP0989)
Subject	CWA Collection System
[REDACTED]	[REDACTED]
[REDACTED]	[REDACTED]
Date Time Stamp	5/1/2012 11:44:34 AM
Photographer	D. Vanlerberghe
Description	Mamajanao pump station building.

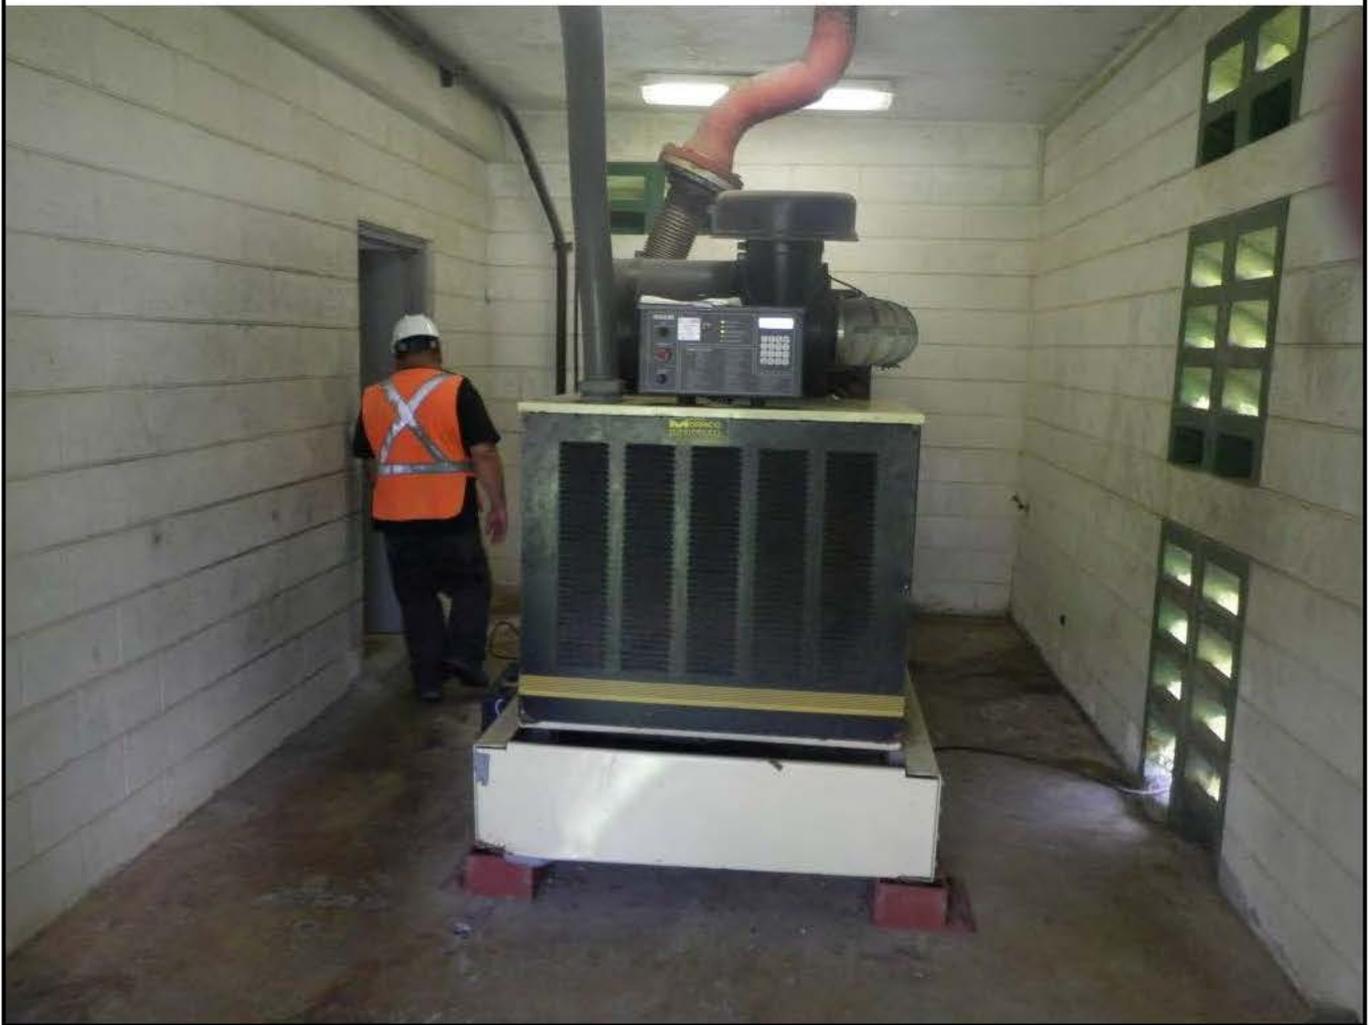
File Name: RIMG0118.JPG

Title	Guam Waterworks Authority (VP0989)
Subject	CWA Collection System
Date Time Stamp	5/1/2012 11:49:19 AM
Photographer	D. Vanlerberghe
Description	Mamajanao pump station standby generator.

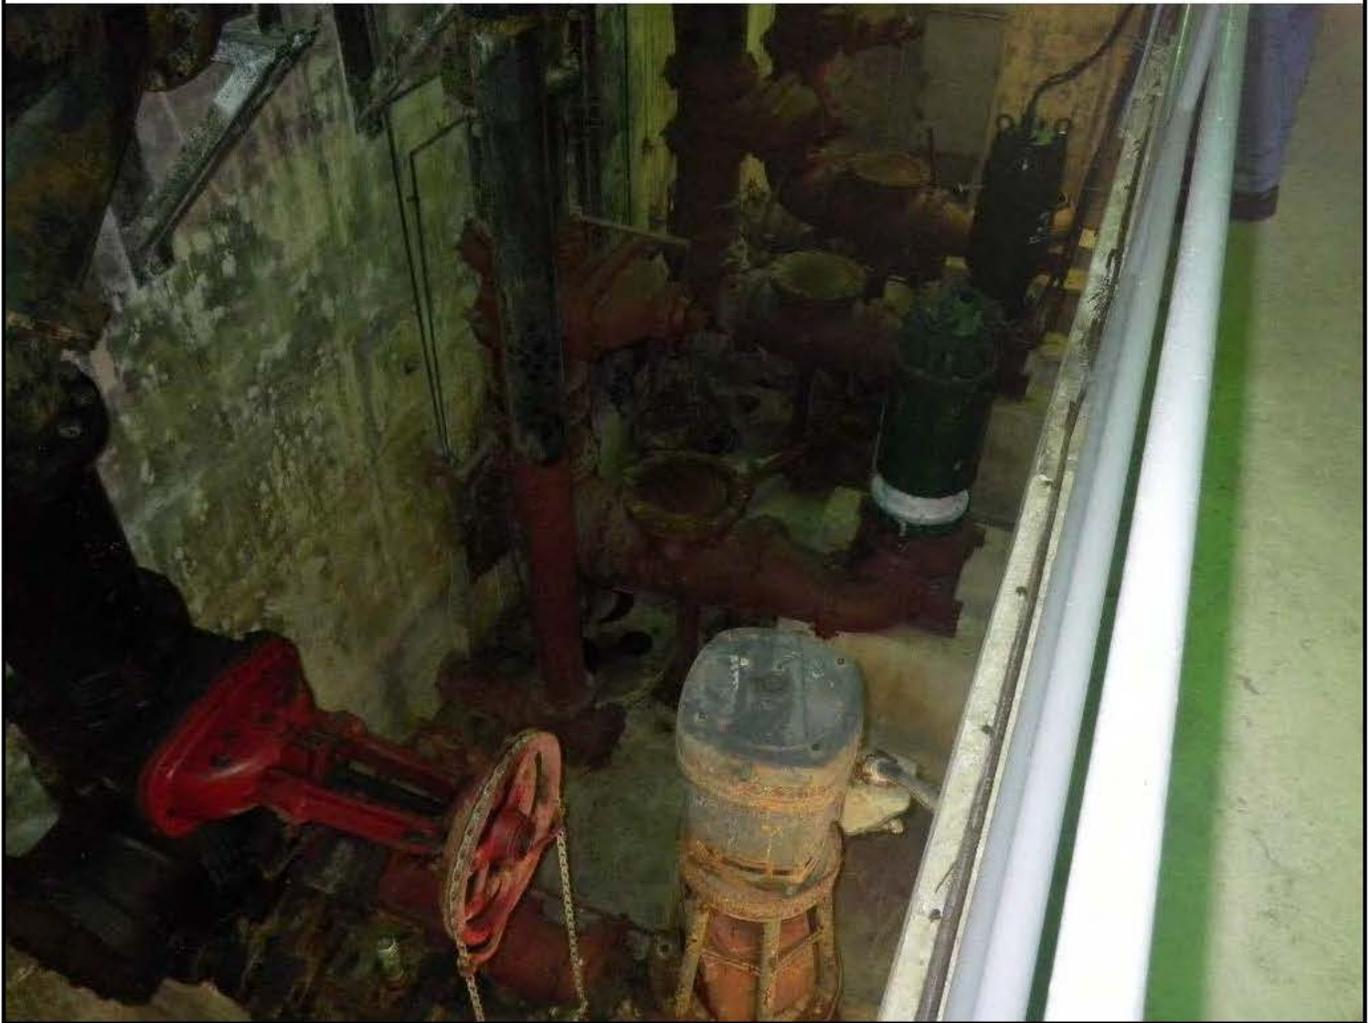
File Name: RIMG0120.JPG

Title	Guam Waterworks Authority (VP0989)
Subject	CWA Collection System
Date Time Stamp	5/1/2012 11:52:57 AM
Photographer	D. Vanlerberghe
Description	Mamajanao pump station pumps.

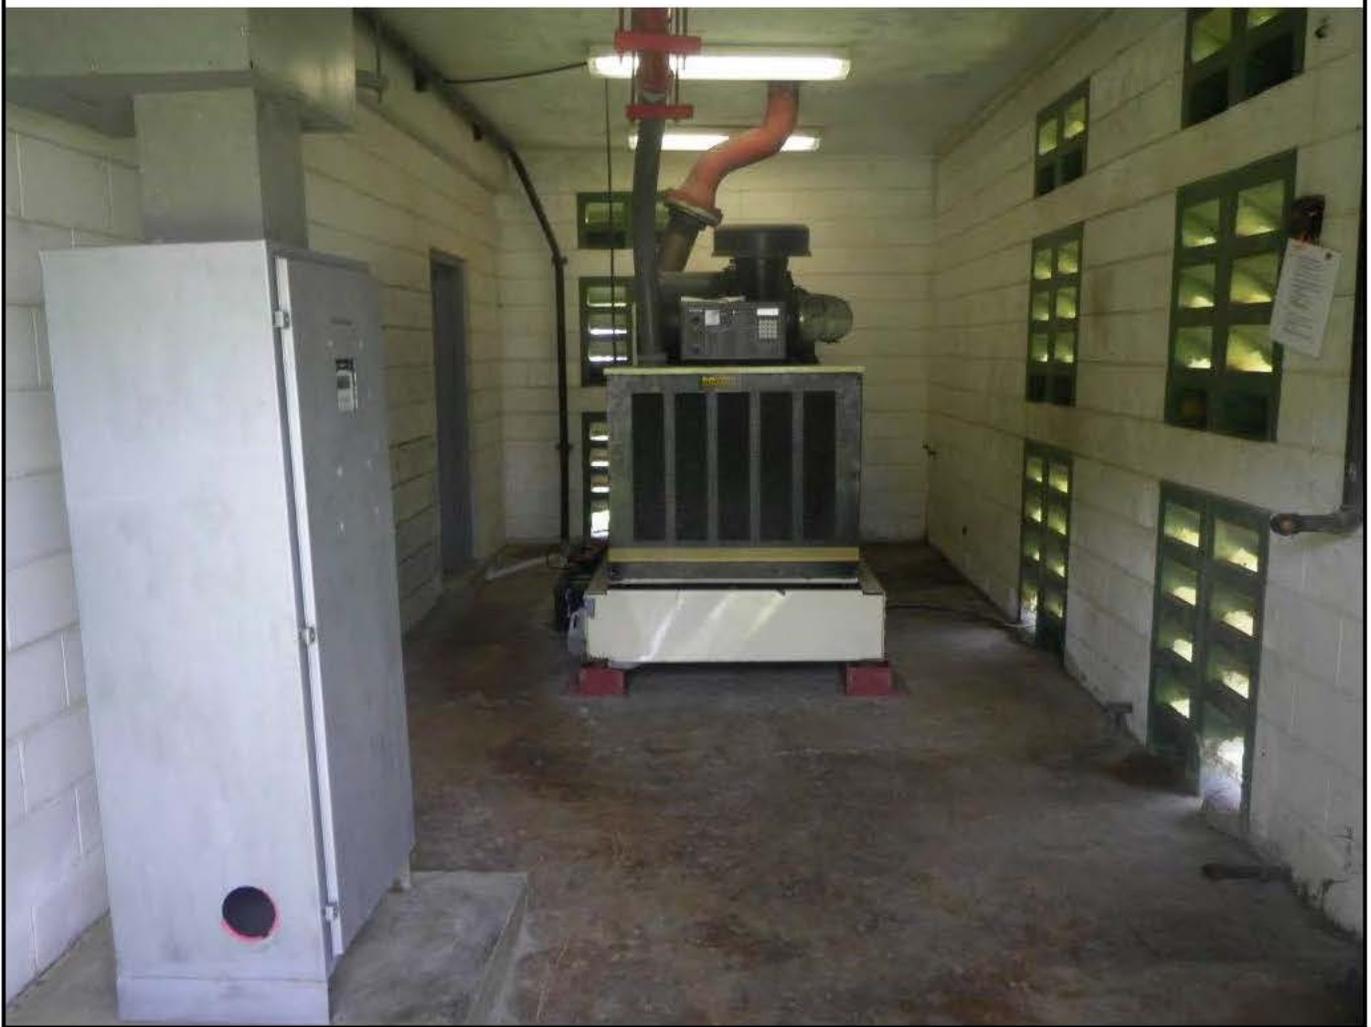
File Name: RIMG0121.JPG

Title	Guam Waterworks Authority (VP0989)
Subject	CWA Collection System
[REDACTED]	[REDACTED]
[REDACTED]	[REDACTED]
Date Time Stamp	5/1/2012 11:55:05 AM
Photographer	D. Vanlerberghe
Description	Mamajanao pump station standby generator.

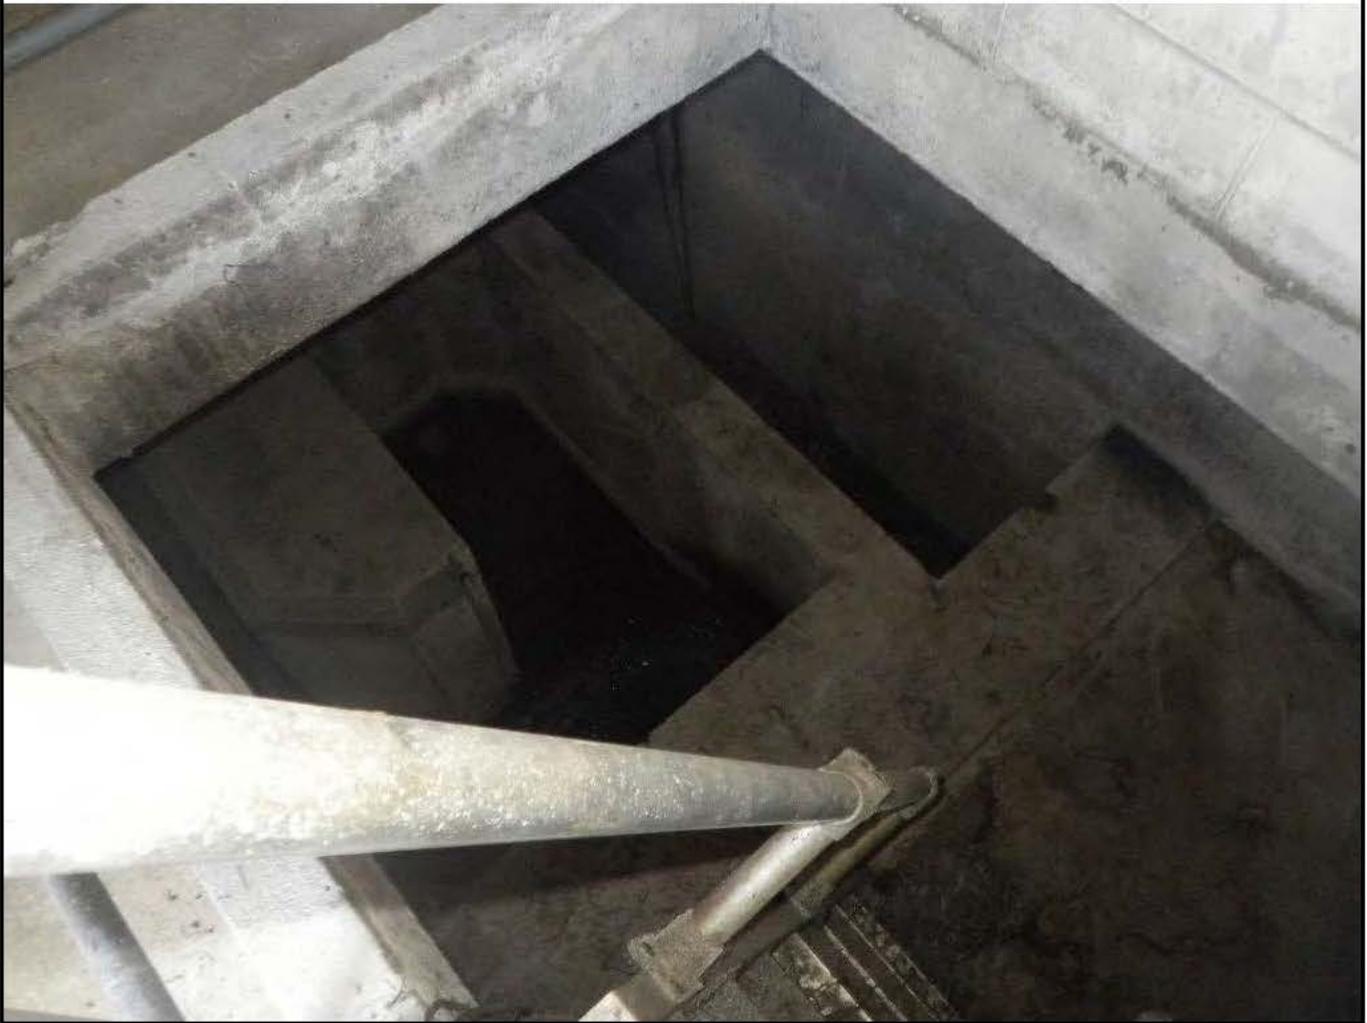
File Name: RIMG0122.JPG

<b>Title</b>	Guam Waterworks Authority (VP0989)
<b>Subject</b>	CWA Collection System
[REDACTED]	[REDACTED]
[REDACTED]	[REDACTED]
<b>Date Time Stamp</b>	5/1/2012 11:56:10 AM
<b>Photographer</b>	D. Vanlerberghe
<b>Description</b>	Mamajanao pump station wet well.

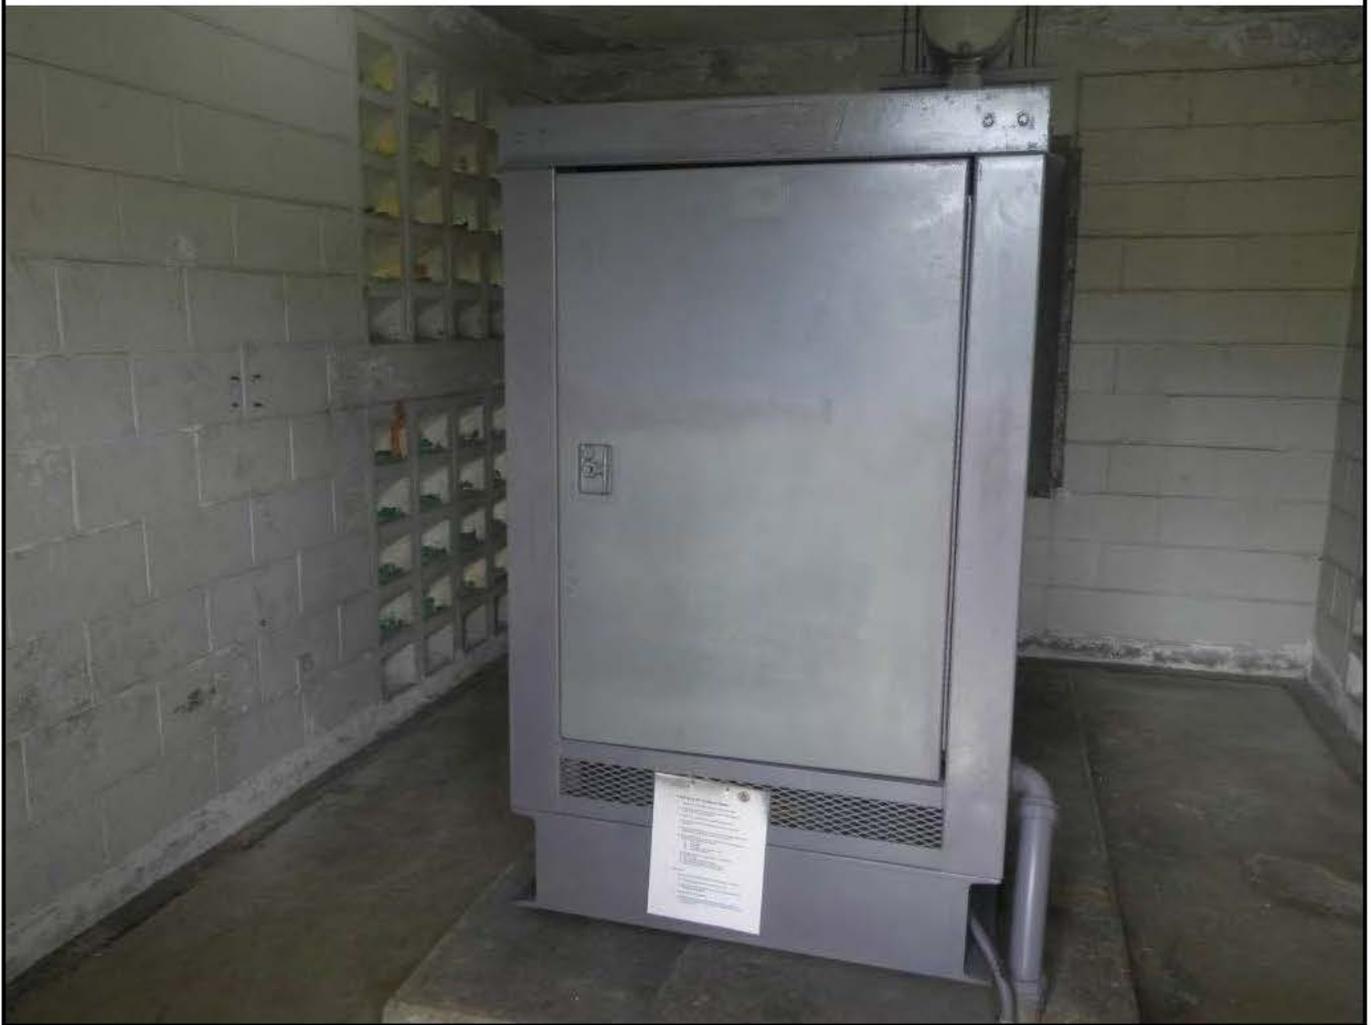
File Name: RIMG0125.JPG

<b>Title</b>	Guam Waterworks Authority (VP0989)
<b>Subject</b>	CWA Collection System
<b>Date Time Stamp</b>	5/1/2012 2:21:13 PM
<b>Photographer</b>	D. Vanlerberghe
<b>Description</b>	Harmon pump station standby generator with built-in fuel tank.

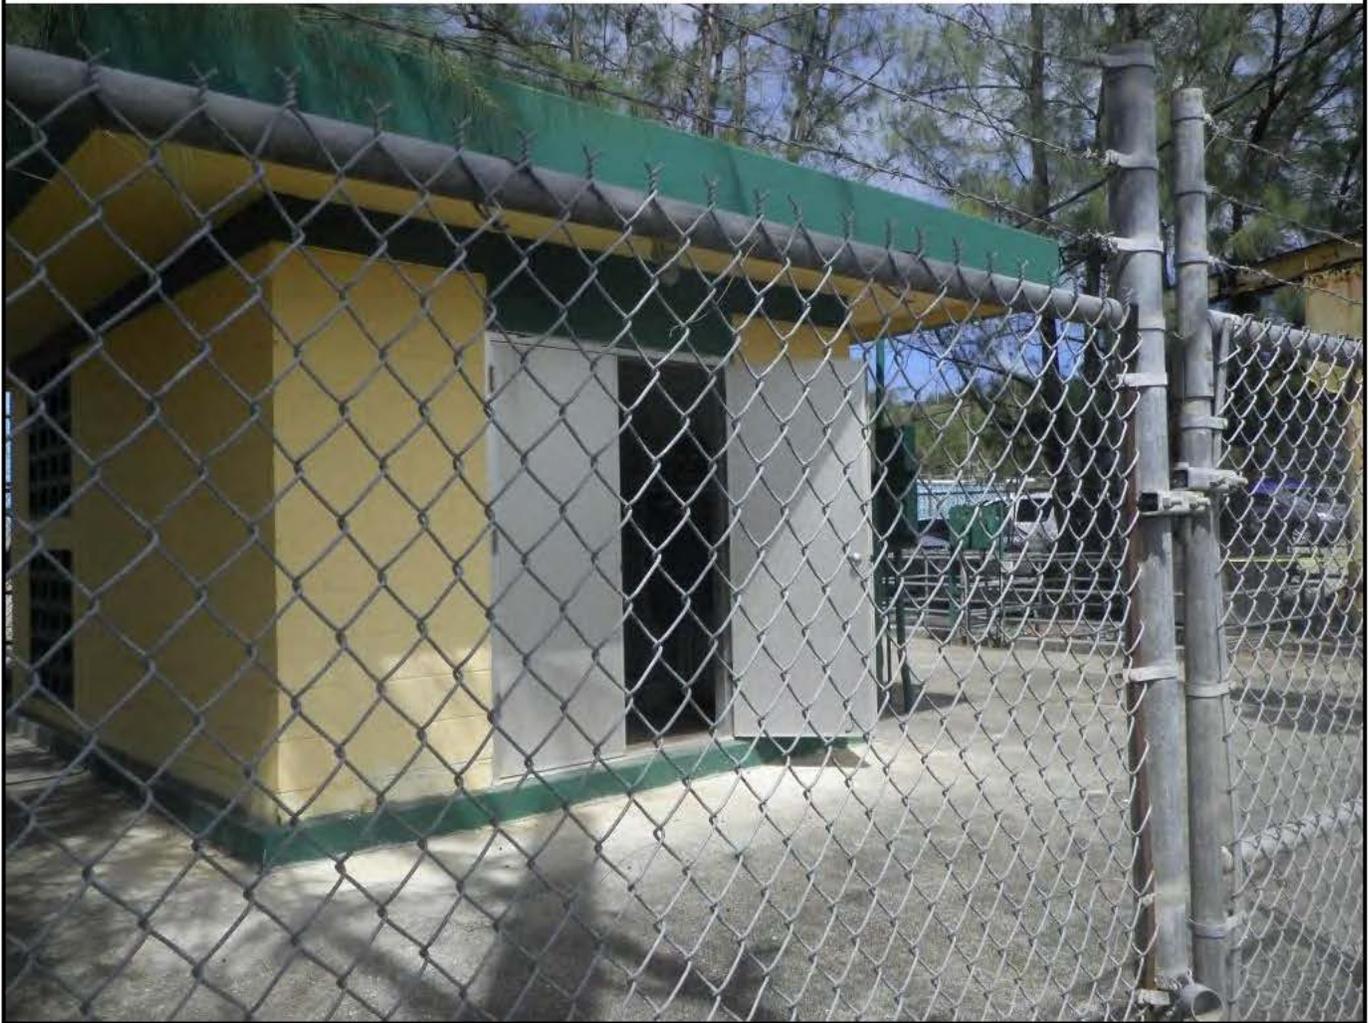
File Name: RIMG0127.JPG

Title	Guam Waterworks Authority (VP0989)
Subject	CWA Collection System
Date Time Stamp	5/1/2012 2:23:32 PM
Photographer	D. Vanlerberghe
Description	Harmon pump station building.

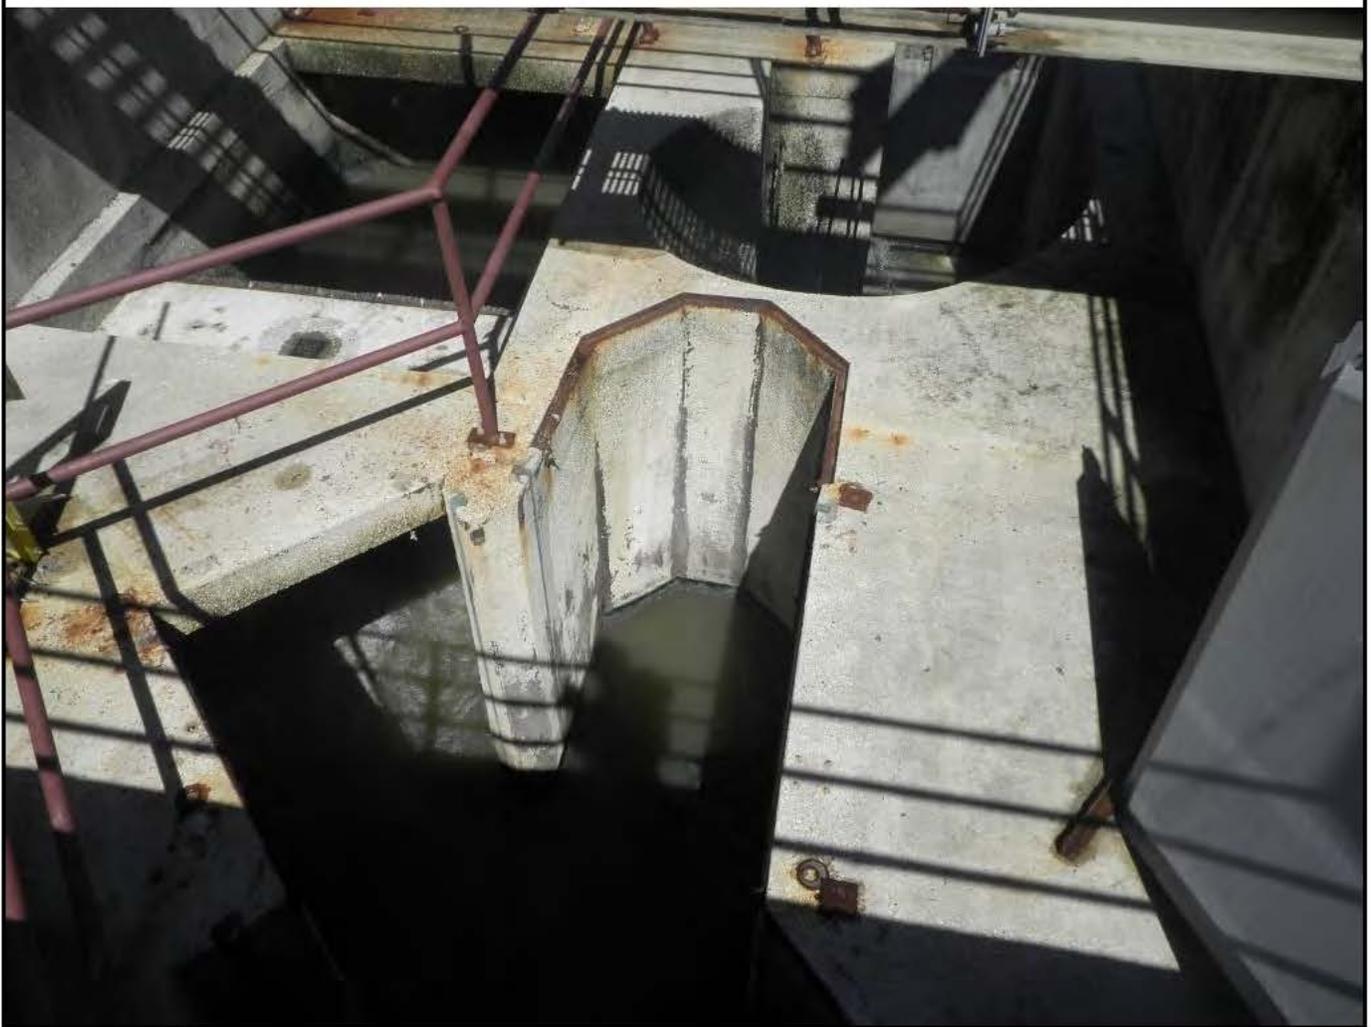
File Name: RIMG0128.JPG

Title	Guam Waterworks Authority (VP0989)
Subject	CWA Collection System
Date Time Stamp	5/1/2012 2:42:18 PM
Photographer	D. Vanlerberghe
Description	Southern Link pump station influent screening area.

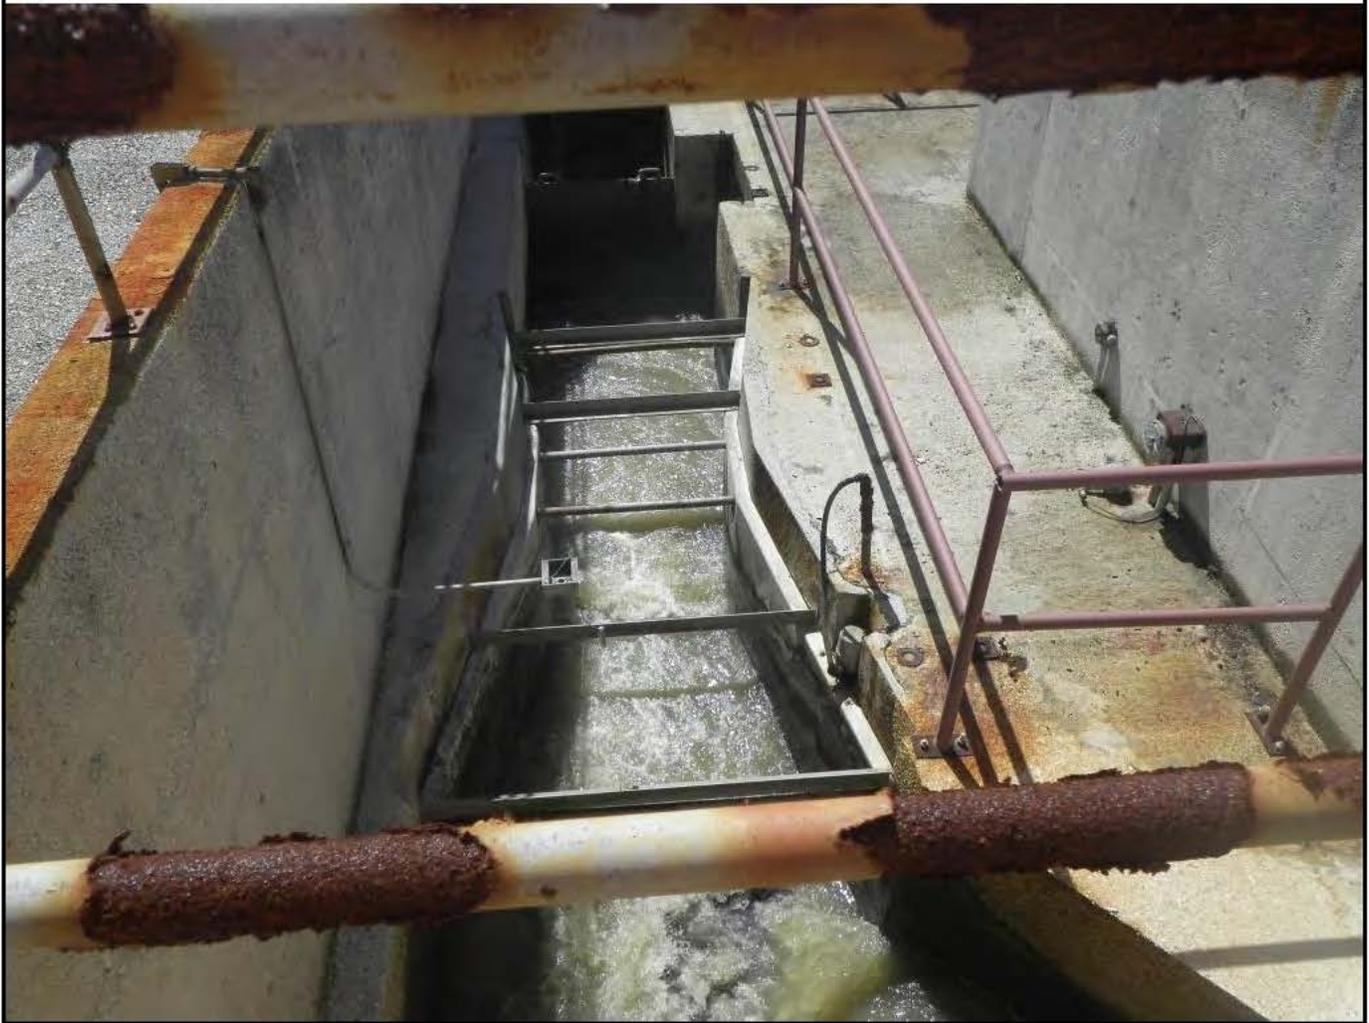
File Name: RIMG0129.JPG

Title	Guam Waterworks Authority (VP0989)
Subject	CWA Collection System
Date Time Stamp	5/1/2012 2:42:47 PM
Photographer	D. Vanlerberghe
Description	Southern Link pump station influent screening area.

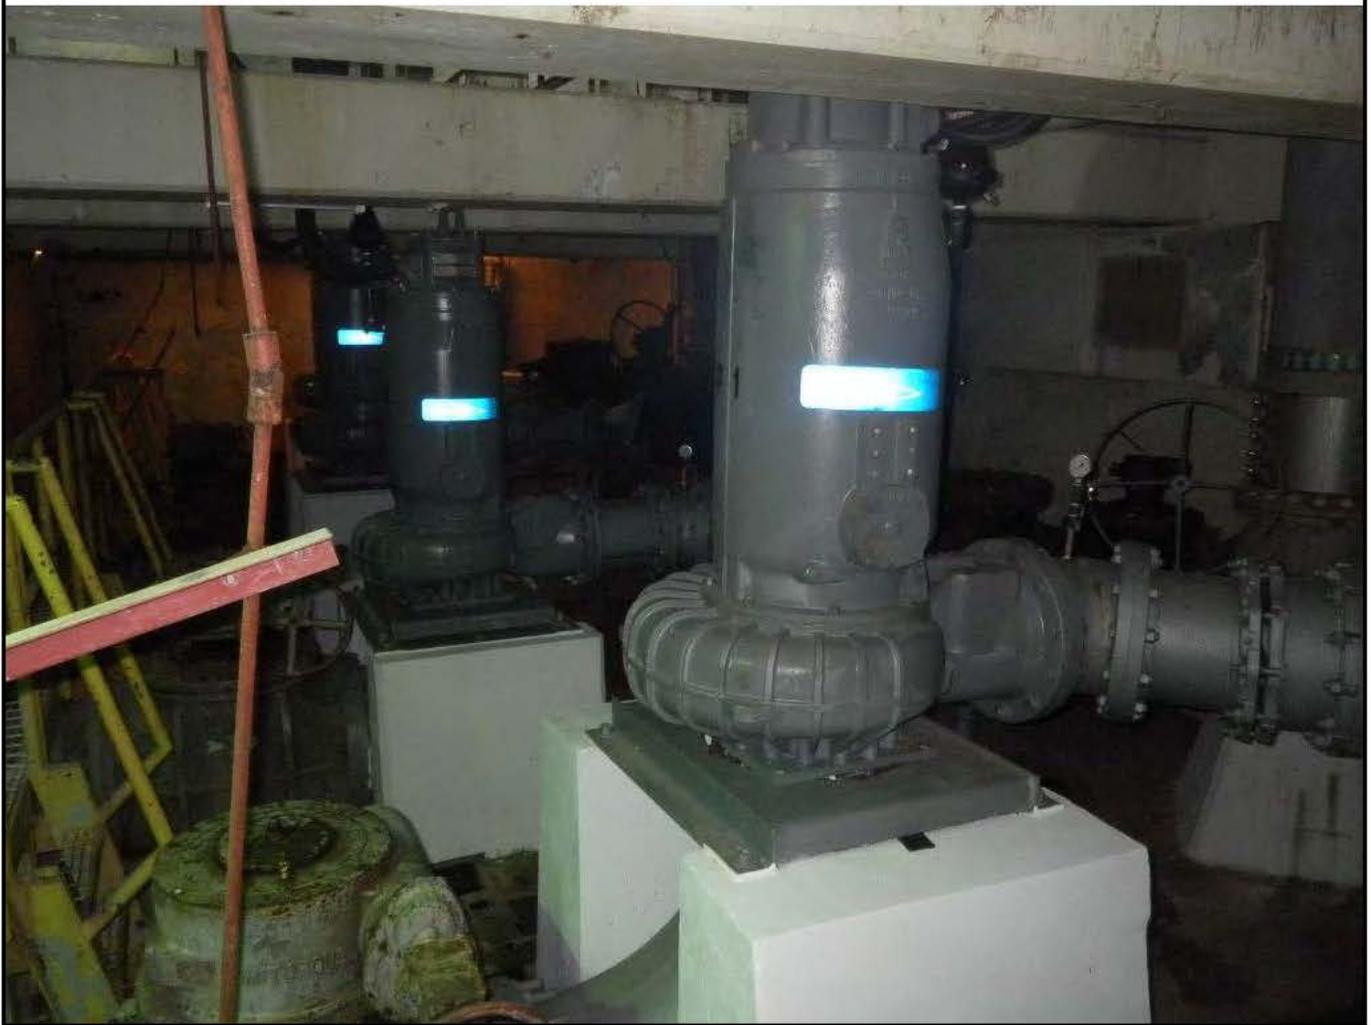
File Name: RIMG0130.JPG

Title	Guam Waterworks Authority (VP0989)
Subject	CWA Collection System
Date Time Stamp	5/1/2012 2:48:18 PM
Photographer	D. Vanlerberghe
Description	Southern Link pump station pumps.

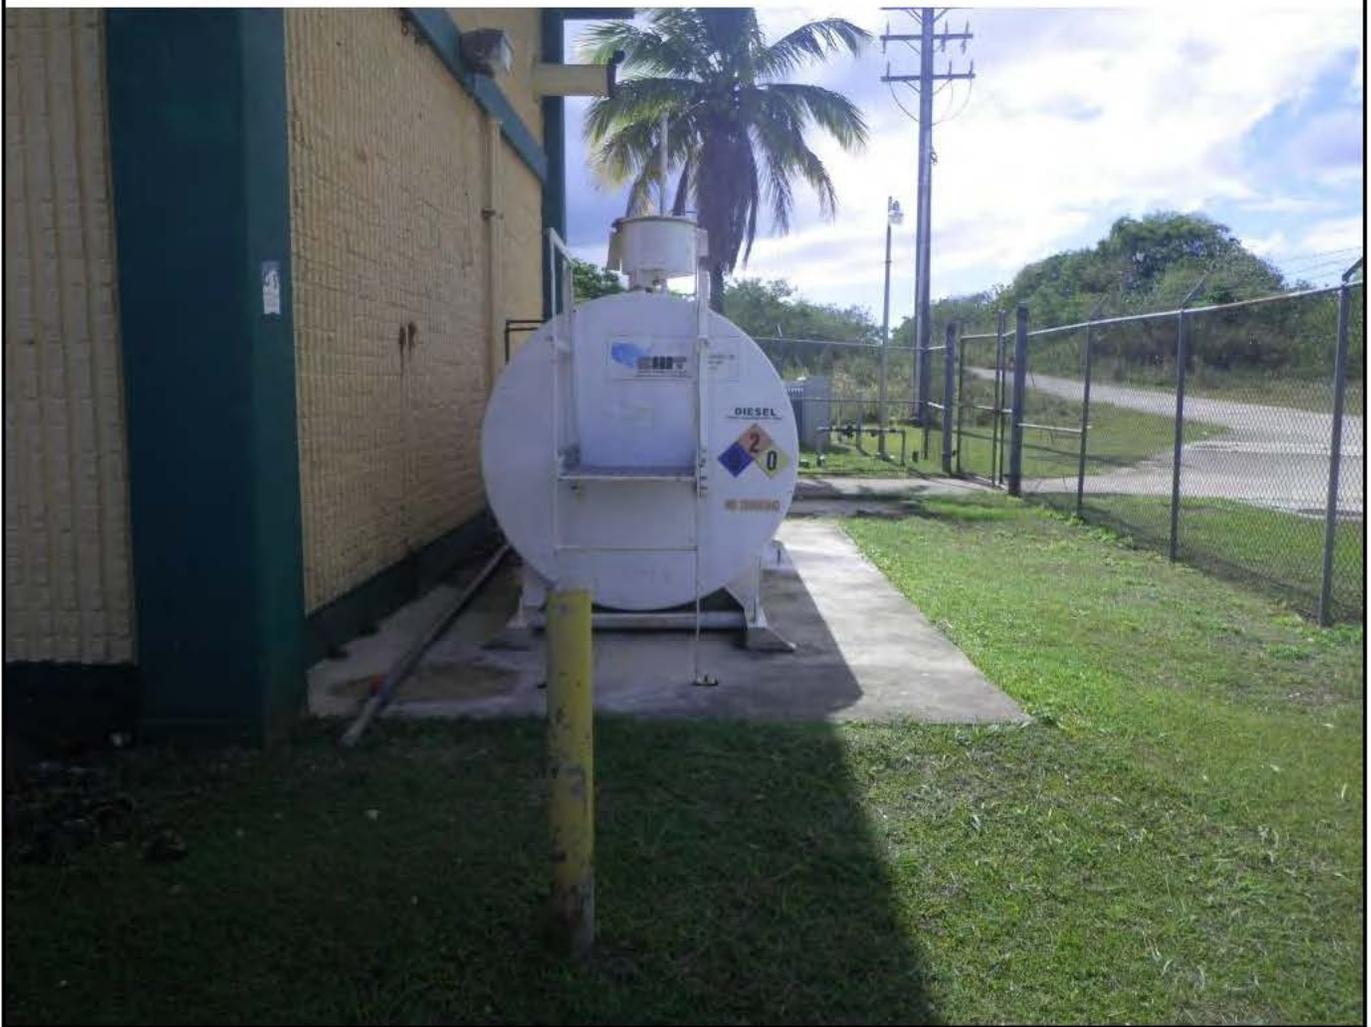
File Name: RIMG0133.JPG

Title	Guam Waterworks Authority (VP0989)
Subject	CWA Collection System
Date Time Stamp	5/1/2012 2:55:05 PM
Photographer	D. Vanlerberghe
Description	Southern Link pump station double-walled diesel fuel tank.

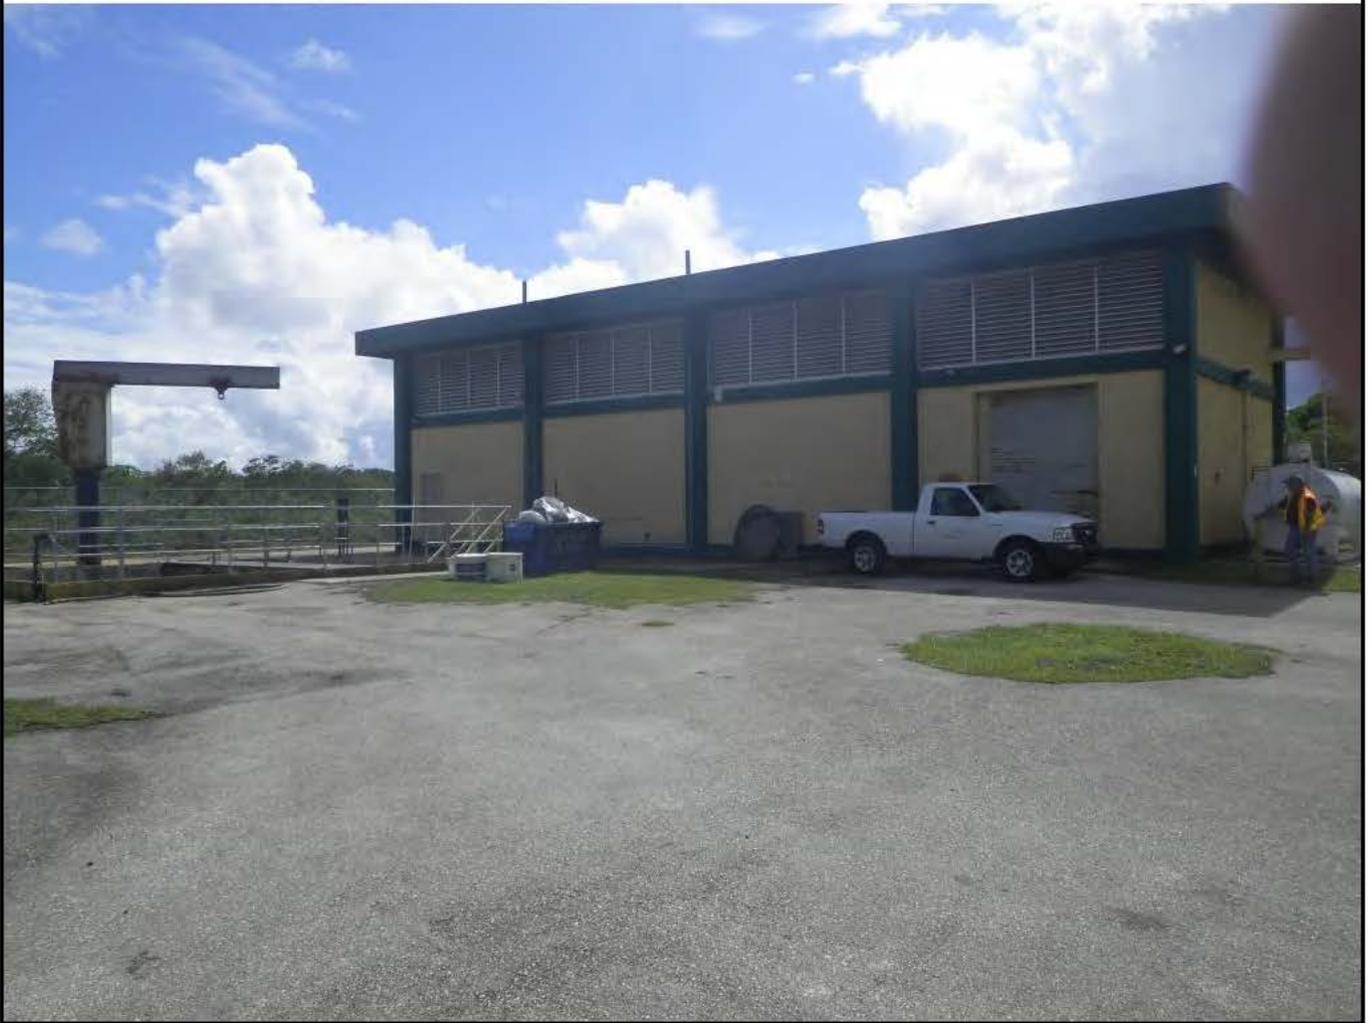
File Name: RIMG0134.JPG

Title	Guam Waterworks Authority (VP0989)
Subject	CWA Collection System
[REDACTED]	[REDACTED]
[REDACTED]	[REDACTED]
Date Time Stamp	5/1/2012 2:56:38 PM
Photographer	D. Vanlerberghe
Description	Southern Link pump station building.
